## RIVER MILE 10.9 REMOVAL ACTION CAPPING OPERATIONS WEEKLY STATUS REPORT

### Summary of capping operations through week ending March 23, 2014

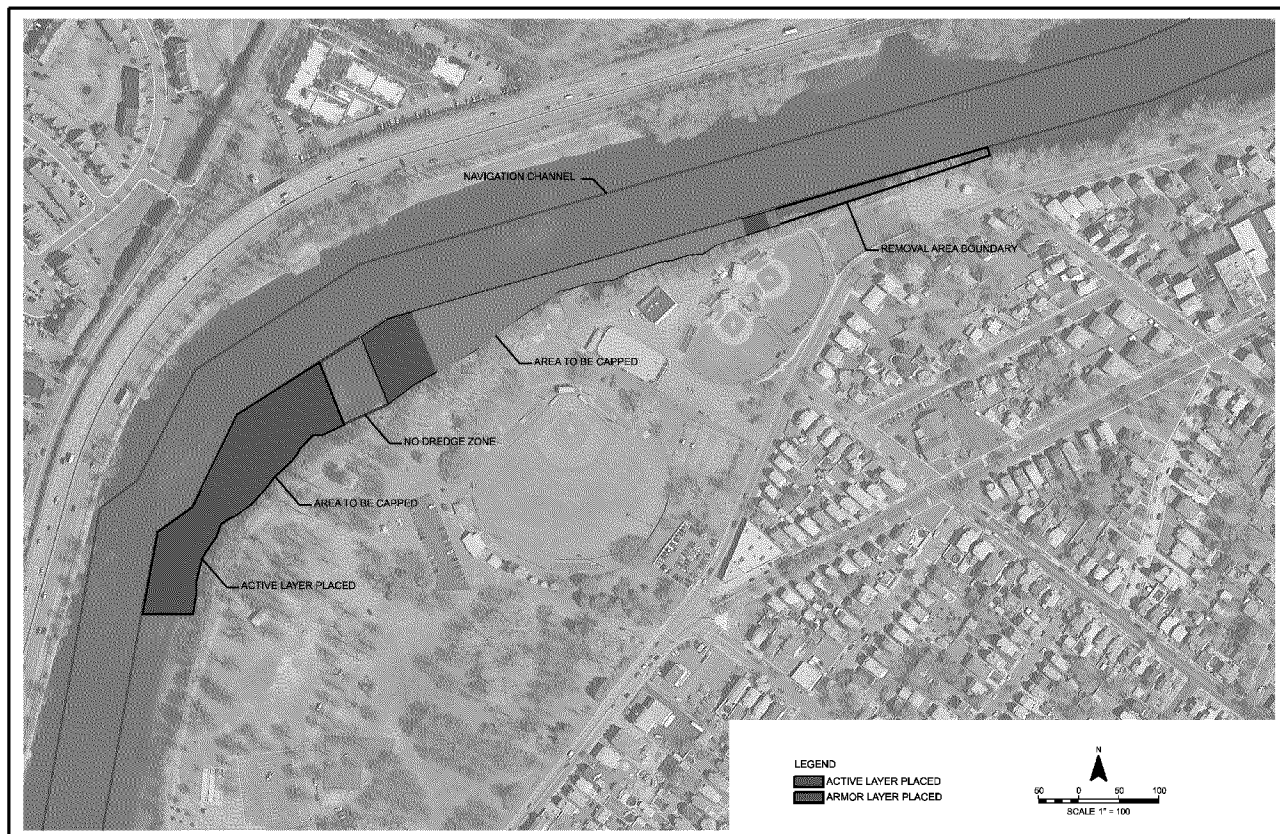
### Capping Progress to Date Shown in Blue

The placement of the fabric and armoring stone continued this week. As of March 23 an estimated 28% of the dredged and capped area has been protected with this armoring layer. Current projections have all work being completed in early May, 2014. The attached figure shows the section of RM 10.9 where the fabric and stone has been placed.
